Emissions Service Action

Code: 2306

Subject: Certain 2010-2014 Volkswagen Vehicles with 2.0L TDI® Clean Diesel Engine ECM Software Update

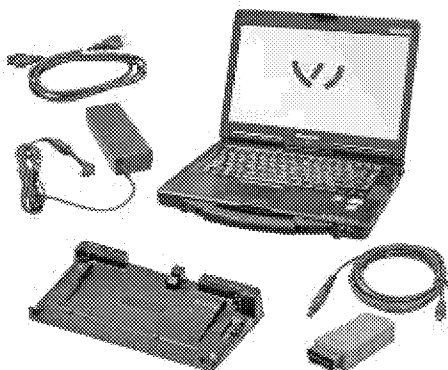
- VAS 6150C Scan Tool (or equivalent)

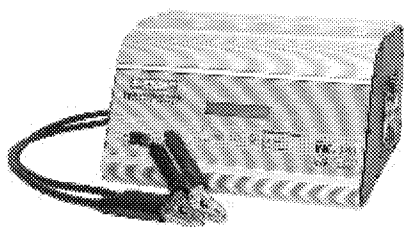
- INC-940 Battery Charger (or equivalent)

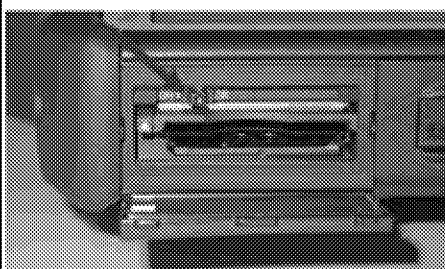
VAS 6150B
(Middle right side behind WIRELESS door)

VAS 6160/-VPC
(Upper left side behind SC/EX door)

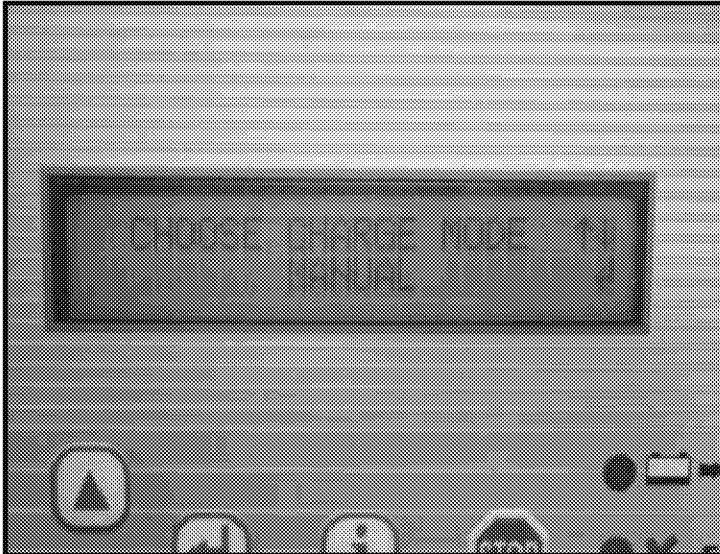
- ⇐ Install the inCharge 940 battery tester onto the vehicle, switch the tester on, then select the “manual” option <as shown>.
- Follow the on screen prompts to charge the battery during the SVM procedure.

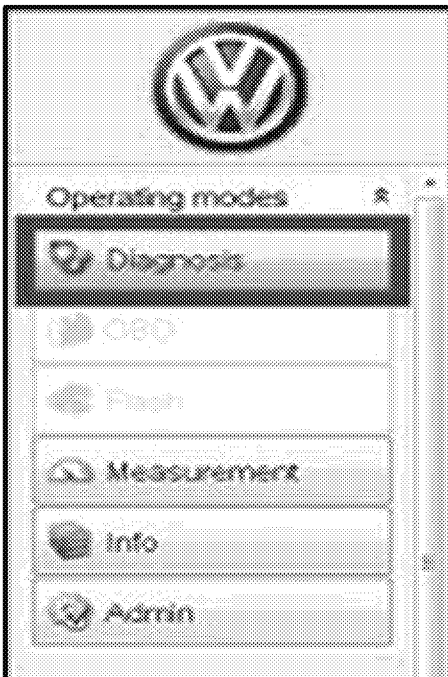
- Switch the ignition on.
- Apply the parking brake.
- Switch the headlights off.
- Attach an appropriate VAS tester to the vehicle.
- Start the ODIS program.
- ⇐ Upon ODIS startup, verify the “Diagnosis” operating mode is selected <as shown>.

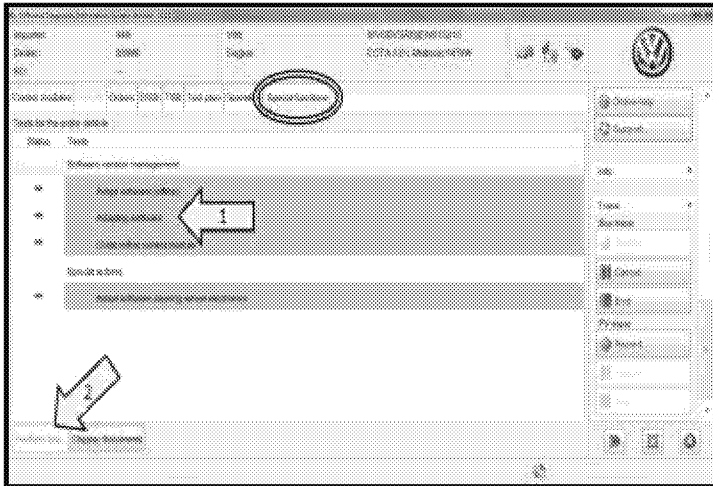
- Once the GFF scan is complete, select “Special functions” <circle>, then “Adapting Software” <arrow 1>, then select “Perform test” <arrow 2>.

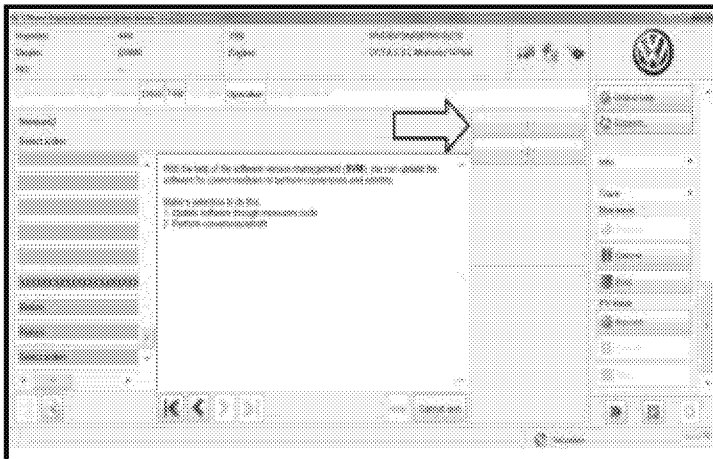
- Select the appropriate option to update “through measures code” <arrow>.

NOTE
Read this screen carefully. The option to update software through measures code is **NOT** always selection #1 on this screen.

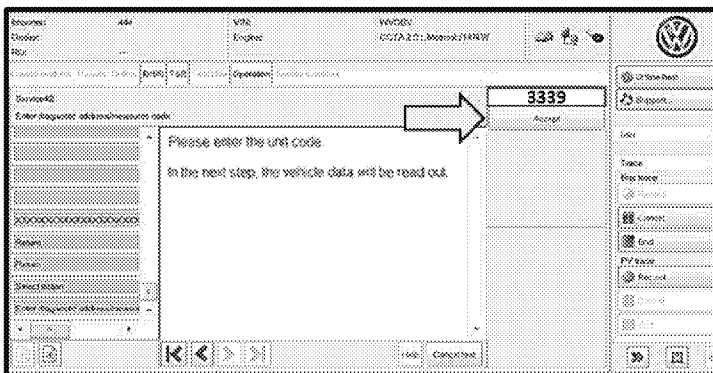
- Enter “3339” <as shown>.
- Select “Accept” <arrow>.

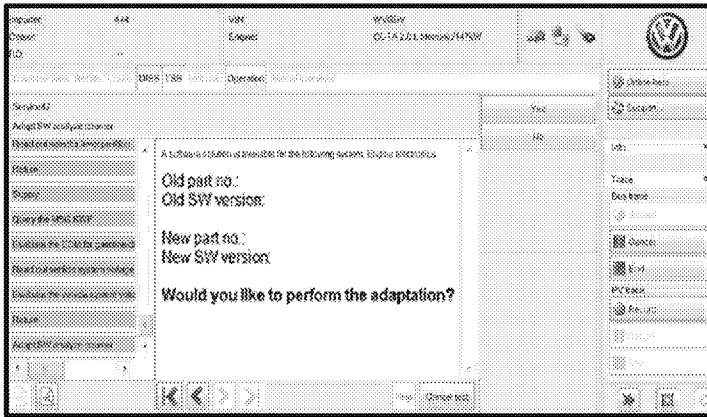
- ⇐ Compare the old and new part number and software version.
- ⇐ If the old and new software versions displayed are the same.

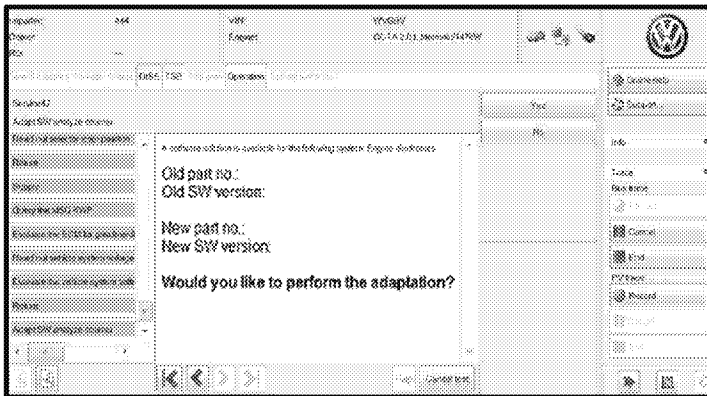
- ⇐ If the old and new software versions displayed are different, Select "Yes" and follow the on-screen prompts to complete the test plan.
- Reference the ECM Software Change Table above for affected ECMs.

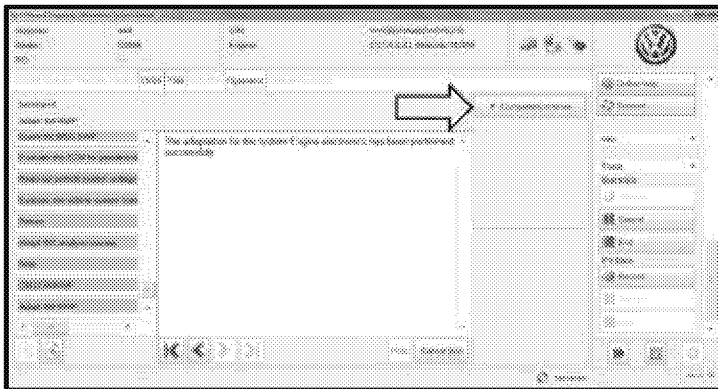
- ⇐ When the SVM update is complete a confirmation message is displayed <as shown>.
- ⇐ Select "Complete/Continue" <arrow>.

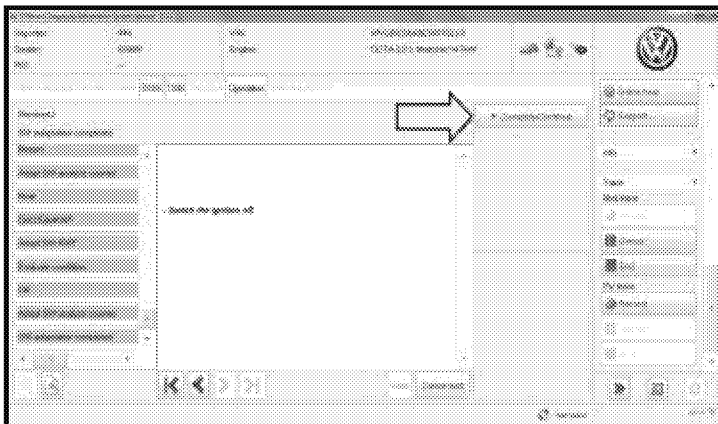
- ⇐ Switch the ignition off, then select "Complete/Continue" <arrow>.

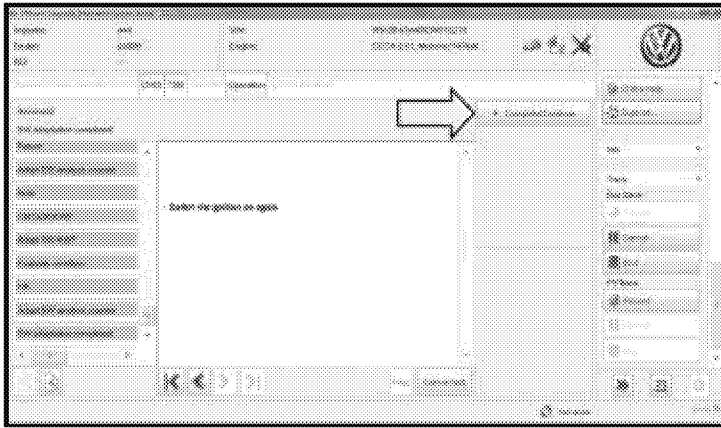
⇐ Switch the ignition on, then select "Complete/Continue" <arrow>.

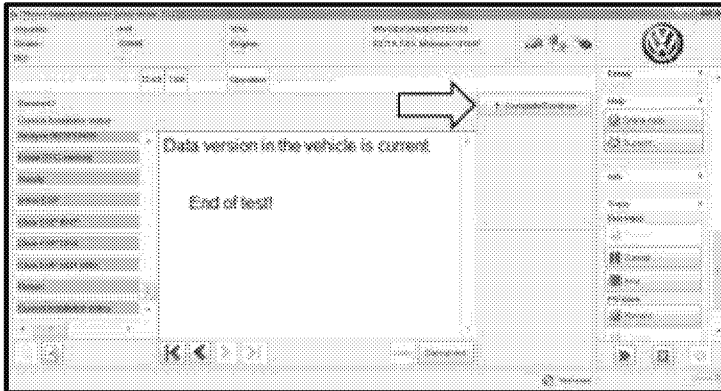
⇐ Select "Complete/Continue" <arrow>.

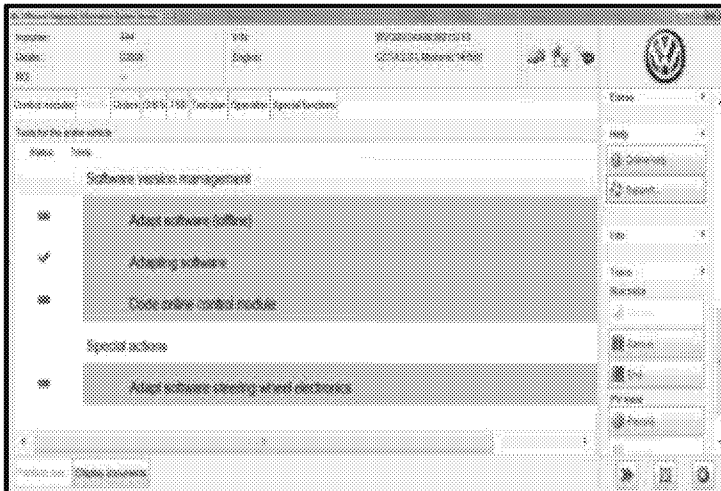
- The green check mark indicates the test plan was successfully carried out.
